Vol. 40 No. 1 June 2023

# Forensic Examination of Post-Fire Damaged Electrical Conductors by Quantitative Measurement

By Mark J. Svare, PhD, PE, DFE (NAFE 851M), Neal W. Hanke, PE (NAFE 1219A), and Niamh Nic Daeid, PhD

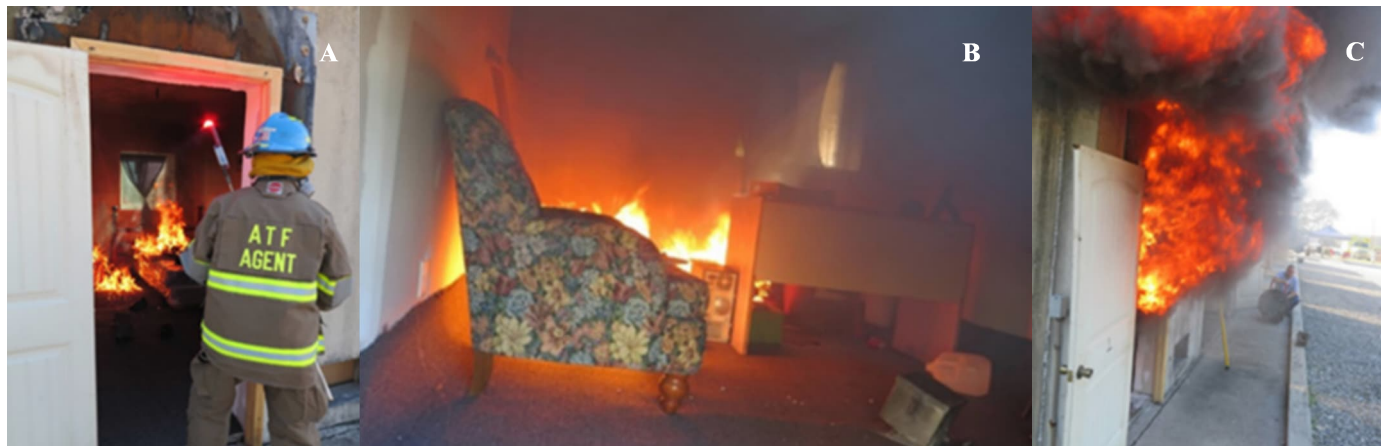
Figure 3

(A) Full-scale compartment fire testing at FLETC, (B) interior view of fire, and (C) post-flashover fire extending outside of compartment.

A total of 63 full-scale compartment fires were conducted at the United States Federal Law Enforcement (FLETC) ATF fire training center in Brunswick, Georgia (**Figure 3**).

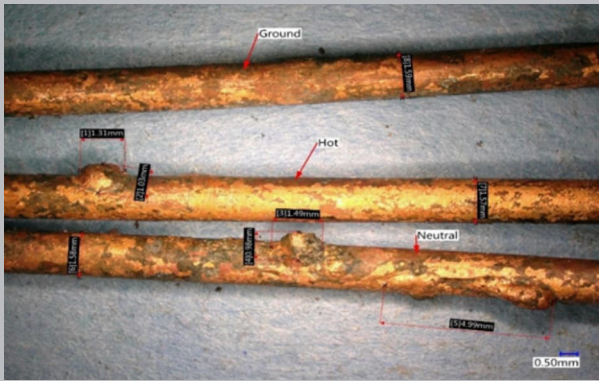
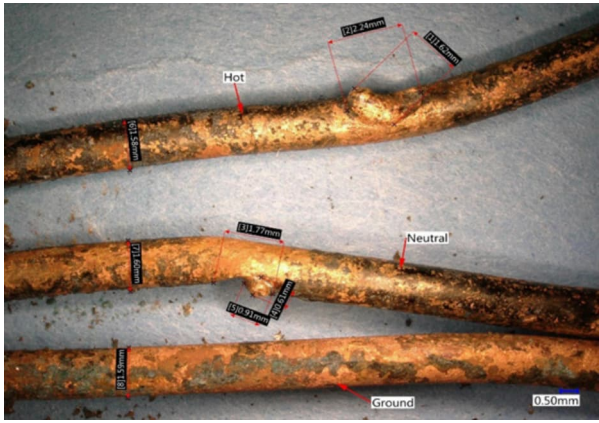
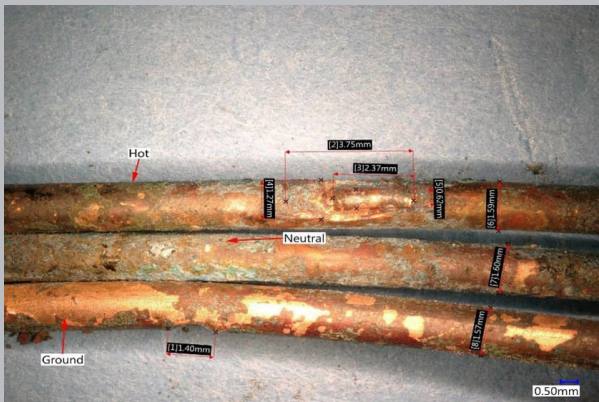
**Figure 7**  
Representative samples of series one – FLETC arc-melted artifacts<sup>27</sup>.

Artifact ID	Wire ID	Conductor Diameter (mm)	Max Arc Melt Size (mm)	Artifact
FLETC 150515	Cell 5 Wire 2	1.6	4.01

FLETC 150515	Cell 3 Wire 1	1.6	2.53

FLETC 150515	Cell 1 Wire 3	1.6	2.37

Localized melting features, clear lines of demarcation, and uniform porosity were observed within arc melt sites. Electrical arc-melt features generated had melted copper

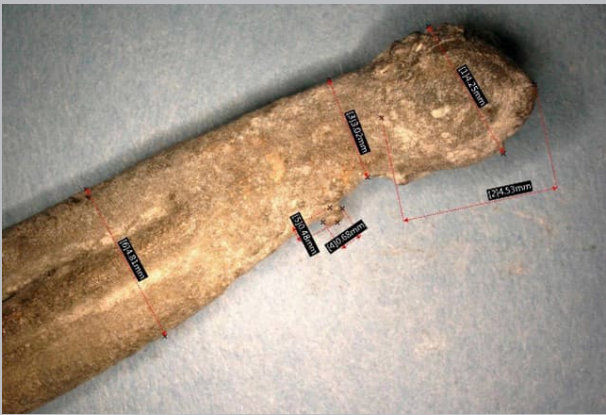
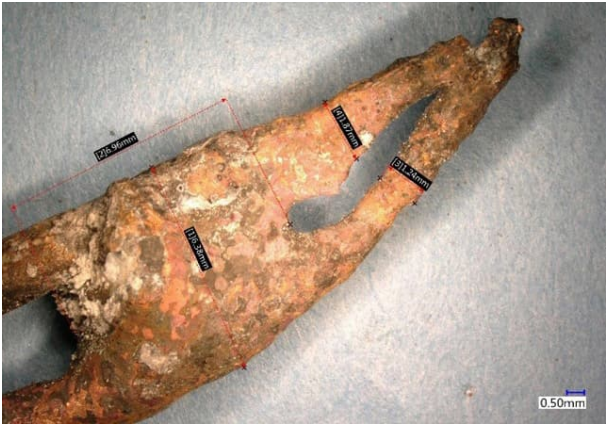
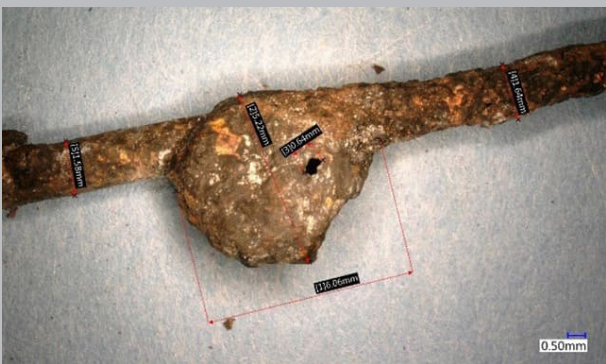
**Figure 8**  
Representative sample of series two - Louisiana (LA) fire melt artifacts<sup>27</sup>.

Artifact ID	Wire ID	Conductor Diameter (mm)	Max Fire Melt Size (mm)	Artifact
Louisiana 2	2	1.6	17

Louisiana 2	3	1.6	32

Louisiana 2	4	1.6	>50

In all cases, the generated fire melt sites had measurable melting features greater than four times the conductor diameter ( $FM > 4CD$ ). The sites exhibited melting, spherical balls (globules). Non-uniform or non-persistent porosity was observed within the mixed gas flame generated
